## **Galvanized Steel Framing for Residential Buildings**

**RESEARCH REPORT RP06-1**

**Galvanized Steel Framing for Residential Buildings**

**7-Year Report  
March 2006**

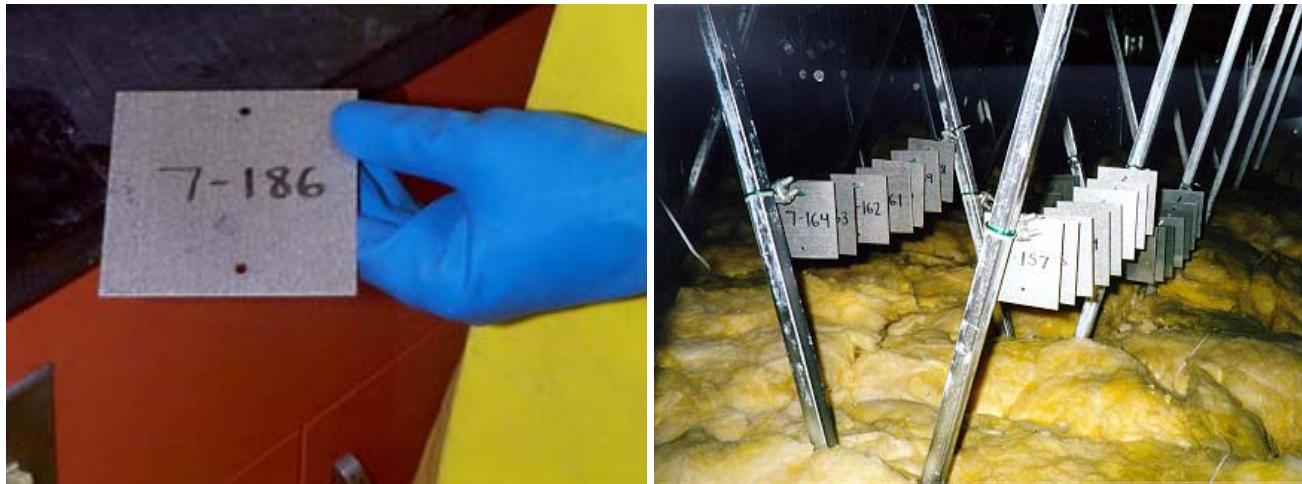
Figure 1 – Plate Samples

The corrosion samples consist of galvanized, galvalume, and galfan coatings in the form of 10 cm x 10 cm (3.94 in x 3.94 in) flat plates and 1-inch (25.4 mm) (nominal) segments of C-section stud. The flat plates allow for a more definitive determination of the specimen's area, and thus a better measure of coating thickness and mass reduction after exposure (Figure 1). The C-section samples have been installed to investigate corrosion performance at the edges and bends of a stud. Both the plate and stud samples have both sides and all edges exposed, which is consistent with the approach used in parallel research efforts in France. The coating thickness specifications for the samples are listed in Table 1.

Knowing the exact dimensions of these coupons provides an accurate determination of coating thickness reduction when the samples are retrieved and analyzed. The stud-type samples are one-inch (25.4 mm) nominal segments of 3-5/8 inch (92.1 mm) (web dimension) C-section studs. The area of these samples cannot be exactly determined; however, their weight loss due to corrosion can be determined upon retrieval. The stud type samples also provide a visual evaluation of any corrosion that may occur at edges or bends of rolled studs.

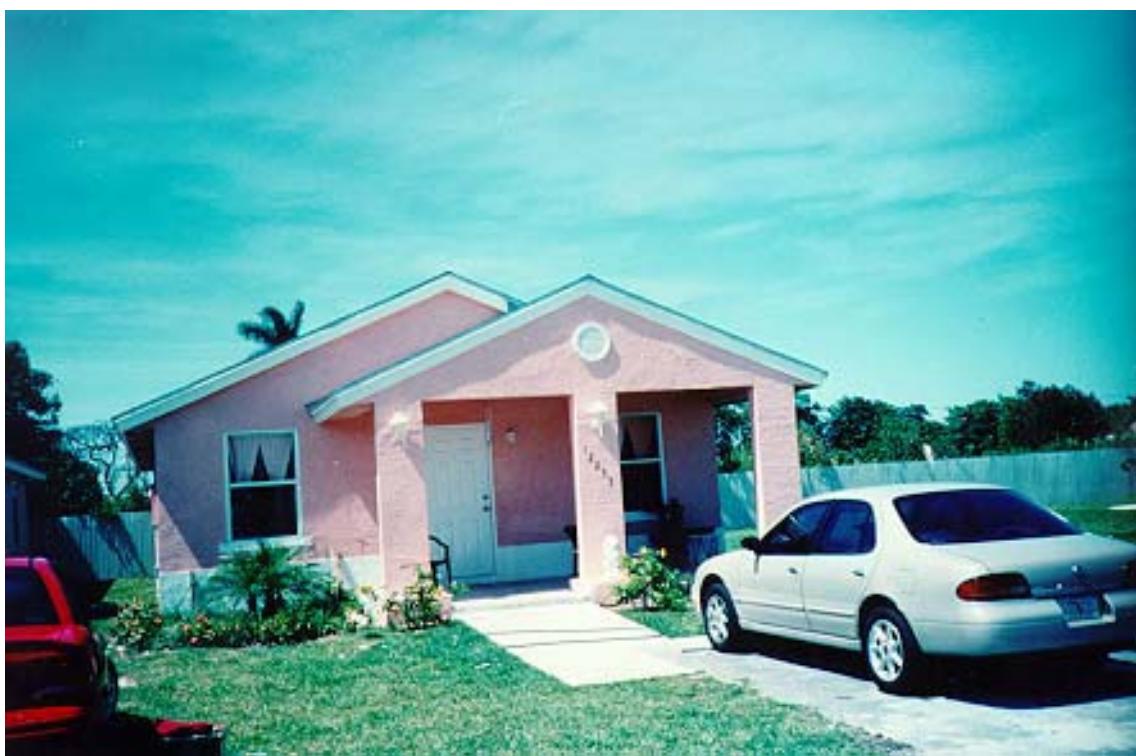
**Figure 2 - Miami, Florida Corrosion Site**

The Miami site (Figure 2) is in a Habitat for Humanity Development in southwest Miami, where 16 of the 90 homes have been framed with steel systems. The site is a single-story steel framed structure with a slab foundation. It has plywood sheathing with a stucco exterior finish. The wall interior is 5/8" (16 mm) painted drywall. The attic has kraft faced (facing the drywall) fiberglass batts with an R-30, while the walls have either R-11 or R-13 batts. The walls are 6" (152 mm) wide. The attic is vented with soffit vents (19 vents total, each is 22" x 4"). No ridge vents are present, and one small gable end vent is visible in the front of the house.

Sample colonies were located in both the attic (see Figure 3) and an exterior wall. The attic colony contained samples that were suspended from the roof framing. This stock of samples includes galvanized, galfan, and galvalume plates and studs. A small quantity of bare samples was also installed. The attic is vented by soffit vents on the east and west sides of the house.

The wall cavity colony has a west-facing exposure, and contained samples which were accessible for retrieval through access panels. The samples consisted of galvanized, galfan, and galvalume stud and plate pieces. The samples were embedded into the fiberglass batt insulation in the wall cavity.

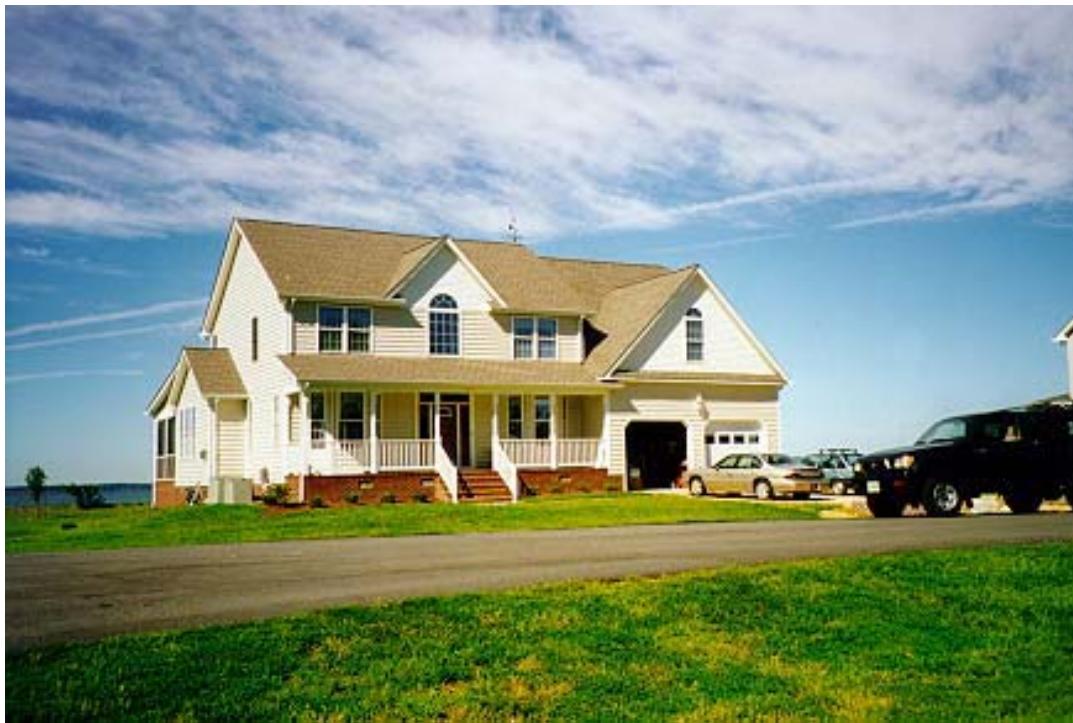
**Figure 4 - Leonardtown, Maryland, Site on Lower Potomac River**

The Leonardtown, Maryland, house (Figure 4) is directly on the lower Potomac River before it empties into the Chesapeake Bay. The two-story home is roughly 75 feet (22.9 m) from the Potomac River, with strong winds often blowing spray towards the house from the brackish river water. The walls were framed with 18 gauge (43 mil) C-section studs, while steel trusses were used for the roof framing. Steel floor joists were used in the crawlspace along with R-19 fiberglass batts. A layer of poly is installed on the crawlspace floor. The attic was insulated with 11 in. (27.9 cm) of blown cellulose. The attic was vented with a ridge vent and soffit vents. The walls consist of 5/8" (16 mm) drywall, wet-blown cellulose (R-13), OSB sheathing, 1" (25.4 mm) of non-foil faced foam cladding (R-5), a Tyvek air infiltration barrier, and vinyl siding. The only notable interior moisture source was a large Jacuzzi tub in the master bathroom. All bathrooms were vented directly to the outside. The foundation was vented with perimeter vents in the block wall

NAHB Research Center personnel installed specimens in the attic, an exterior wall, the crawl space, and under the outdoor deck.

The attic colony contained all three coating types in both plate and stud form. These specimens were suspended in the attic with either vinyl cord or string. A second set of samples was also embedded in the attic's cellulose insulation. The purpose of this second set was to investigate any interaction between the galvanized coating and the cellulose insulation.

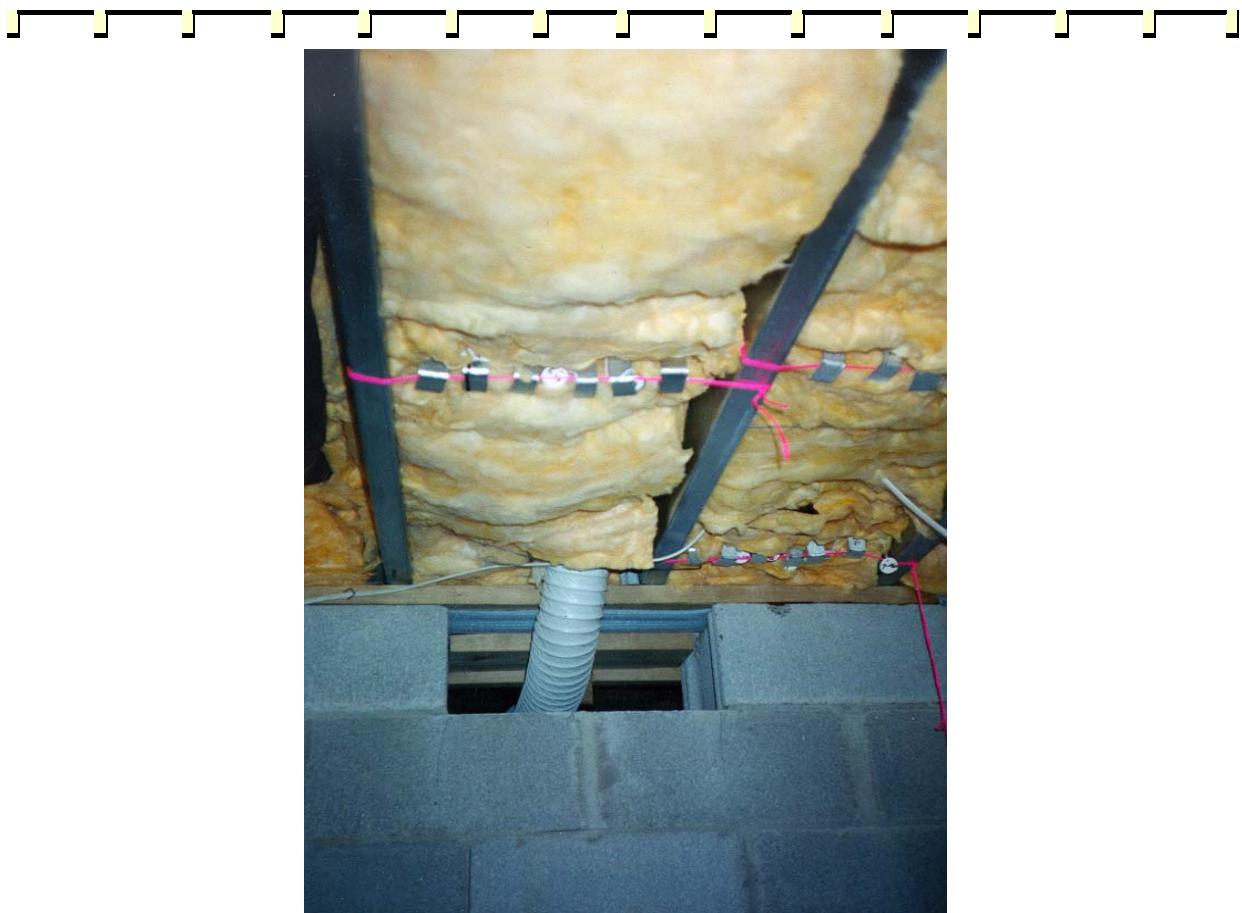
**Figure 5 - Crawlspace Specimens Embedded in Floor Insulation**

The crawlspace contained a set of suspended samples and another set that was partially embedded in the fiberglass batts between the joists (see Figures 5 and 6). The suspended set was fully exposed to the ambient crawlspace environment, and contained plates of all three coating types. Galvanized, galvalume, galfan, and bare (stripped) stud-type specimens were also suspended. The bare samples displayed extensive corrosion after just two months of exposure, indicating the aggressive environment in the crawlspace (see Figure 7). The set that was partially embedded in the floor insulation contained galvanized and galvalume stud samples. Their installation was designed to duplicate the exposure conditions of a floor joist.

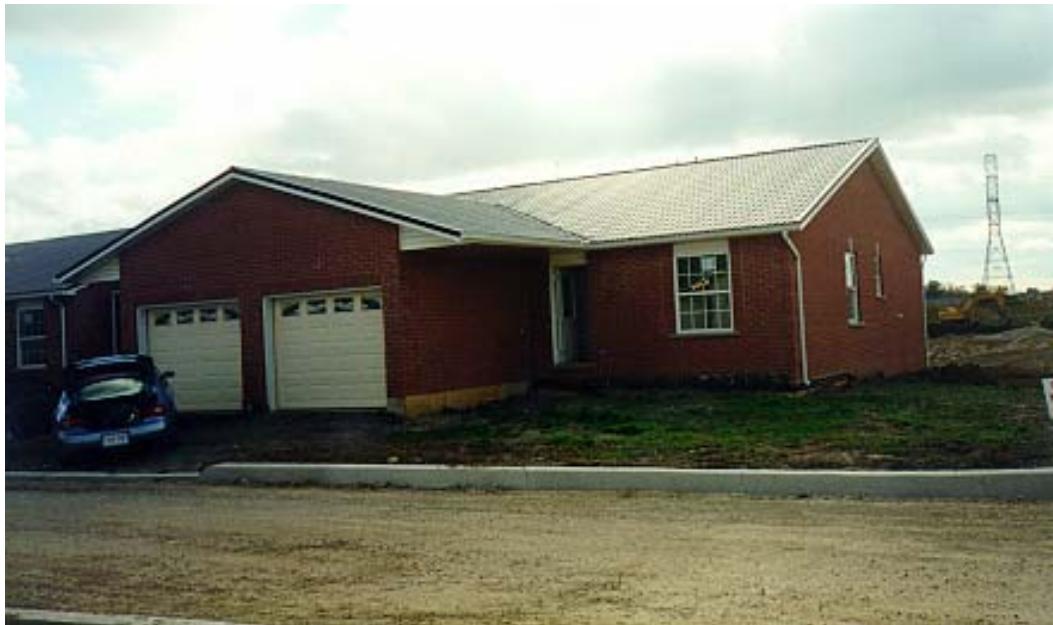
**Figure 8 - Hamilton, Ontario, Test Site (Front View)**

The Hamilton, Ontario, site (Figures 8 and 9) is a single-story in a retirement community. It is the end unit, with a walk-out basement. Three of the four basement walls are concrete block, with the fourth wall (east facing) being steel-framed wall. The framed walls are designed as follows: interior wall covering is 5/8" (15 mm) drywall, behind which a poly vapor barrier is installed. The walls are insulated with R-13 fiberglass batts. Beyond the framing is 1-1/4" (32 mm) of foam sheathing (R-7). Outside of the foam sheathing is a 1" (25.4 mm) air gap, with a brick veneer finish beyond this.

The duplex structure was equipped with both corrosion samples and monitoring equipment in winter 1997. The house has a brick veneer and is located in an industrial-type air quality environment. Samples and monitoring sensors were installed in the attic and an exterior basement wall.

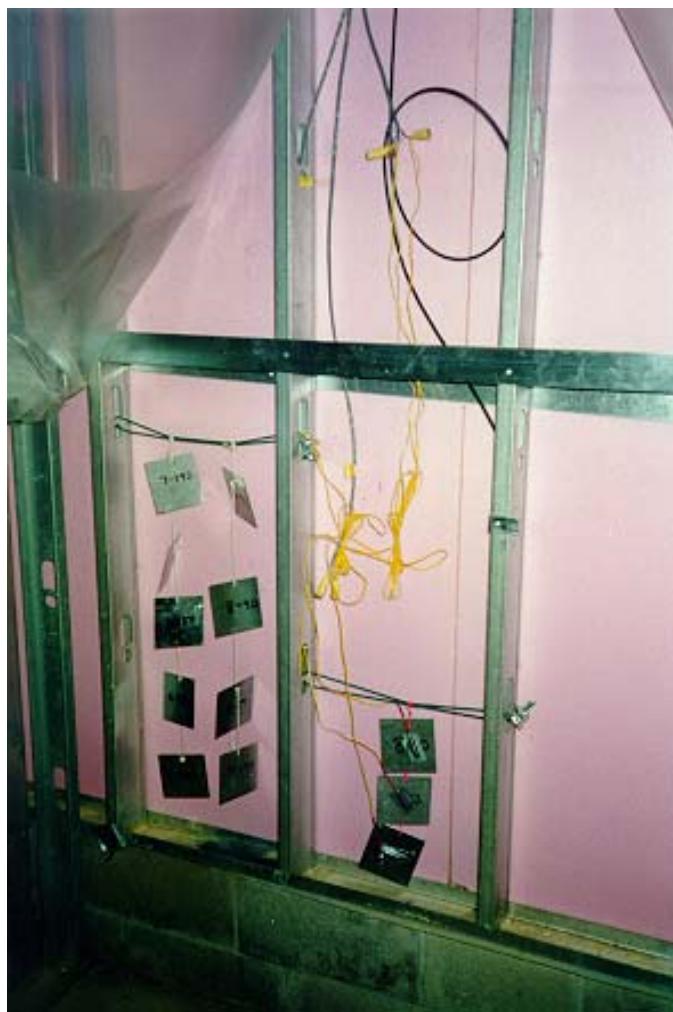
**Figure 10 - Wall Cavity Specimens and Sensors in Hamilton, Ontario, Site**

The exterior wall colony in the Hamilton house was located in the basement's framed wall (see Figure 10). Galvanized, galfan, and galvalume samples were installed in the wall. As in the attic, thermistors were installed to monitor the surface temperature of the three sample types, and two additional sensors monitored the temperature of the wall's base plate and a steel wall stud. The wall cavity ambient relative humidity and temperature was also recorded. Lastly, a time of wetness sensor was mounted to a wall stud to quantify the frequency of condensation on the stud.

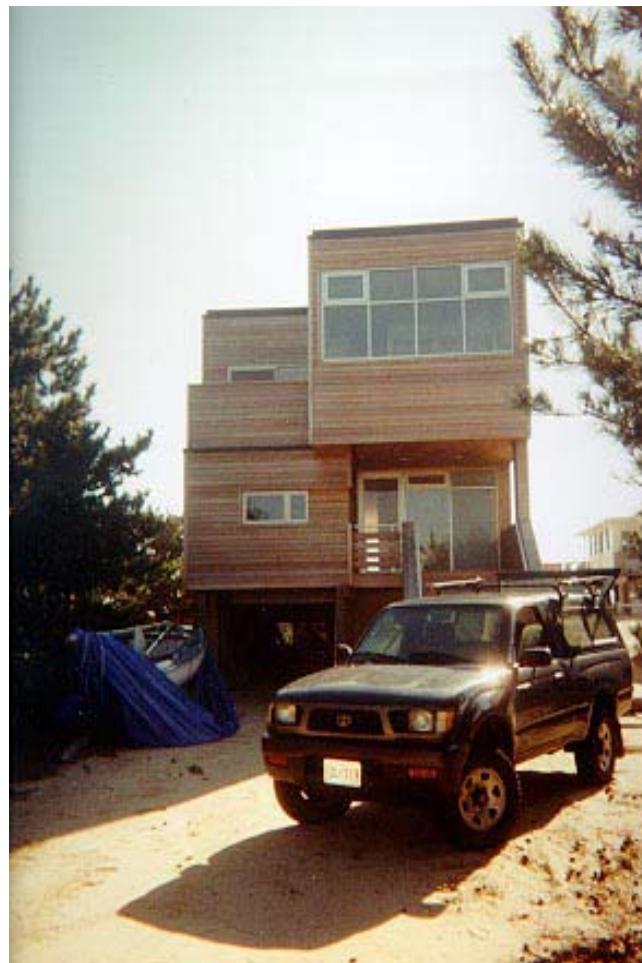
Figure 11 – New Jersey Site

The Long Beach Island, New Jersey site (Figure 11) was the last addition to the research study. The site is a beachfront house on the New Jersey shore, and is separated from the ocean by a low-lying dune roughly 1/4 mile (400 m) wide (see Figure 12). The house was originally a one-story structure, and was remodeled to include a new second floor and roof that are both framed with cold-formed steel (Figures 13 and 14). The house is occupied primarily during the summer season, and is left vacant during the winter.

The house foundation is on wooden pilings. These are original to the house although additional structural members were added during the remodeling. The crawlspace is a loosely enclosed area used for storage and possibly parking. The wood sheathing around the crawlspace is light and serves as a blow-away wall in the event of flooding. The first floor joists are mounted on the pilings. The underside of the joists, which are mostly wood, is covered with 1/2" (13 mm) Celotex Tuff R (R3.8) and 6" (152 mm) fiberglass batts are stuffed between the joists (R30).

Three sample colonies were established in the New Jersey site. The first was located in the joist system that supports the first story. A full set of studs and plates was located in the space between the joists. This location should carry some risk of corrosive conditions because it is not immune to infiltration air and outdoor conditions. The second colony was located on a cantilevered deck that hangs off the second story of the home and faces the beach. The joist bays under the deck are vented, which presented an opportunity for ocean breezes to deposit salt and/or moisture on the samples. A full set of plates was installed under this deck. The third colony was in a steel-framed exterior wall on the second floor. The colony contained plate samples.

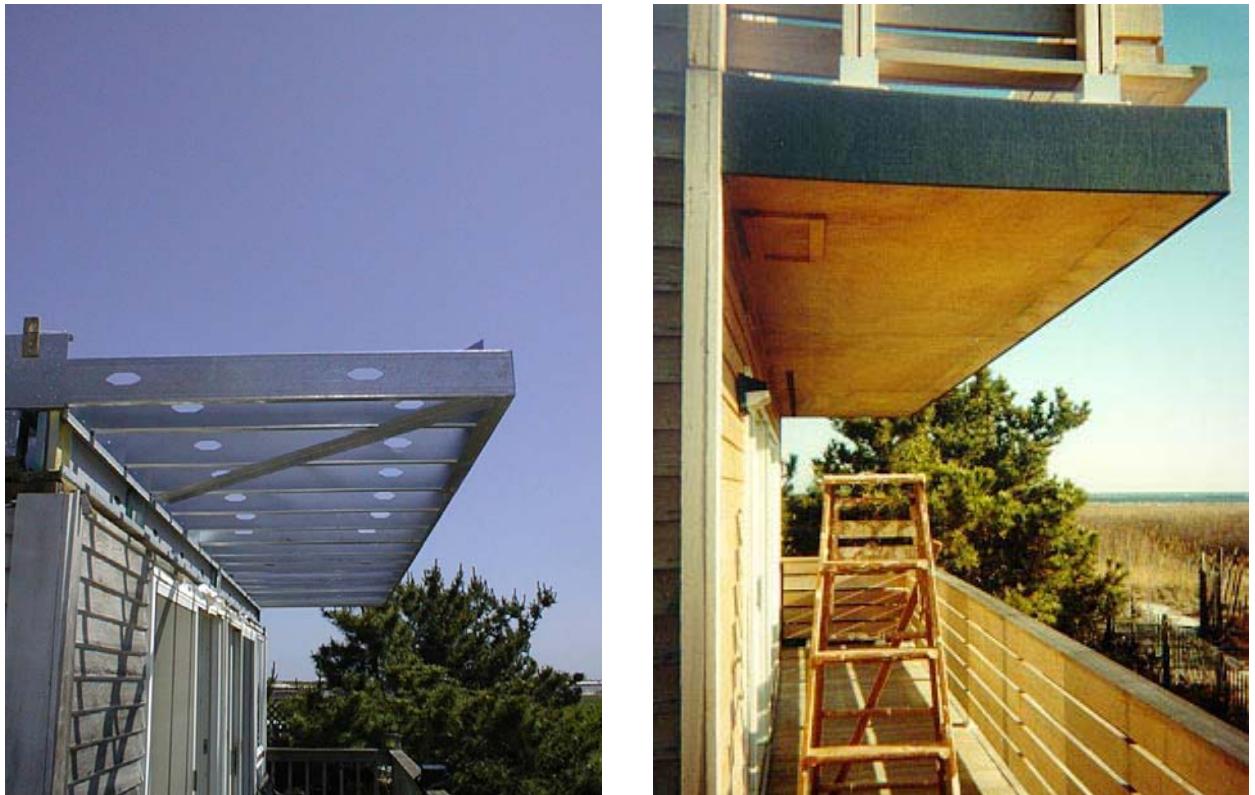
**Figure 13 –New Jersey Site Under Construction**

The site is a renovated 1-story wood frame structure that has been added to with an expanded first story and a completely new second story. The additions are framed with cold-formed steel. The site is beachfront although the beach is a substantial distance from the house across grass dunes. The front of the house faces west and rear towards the ocean (east).

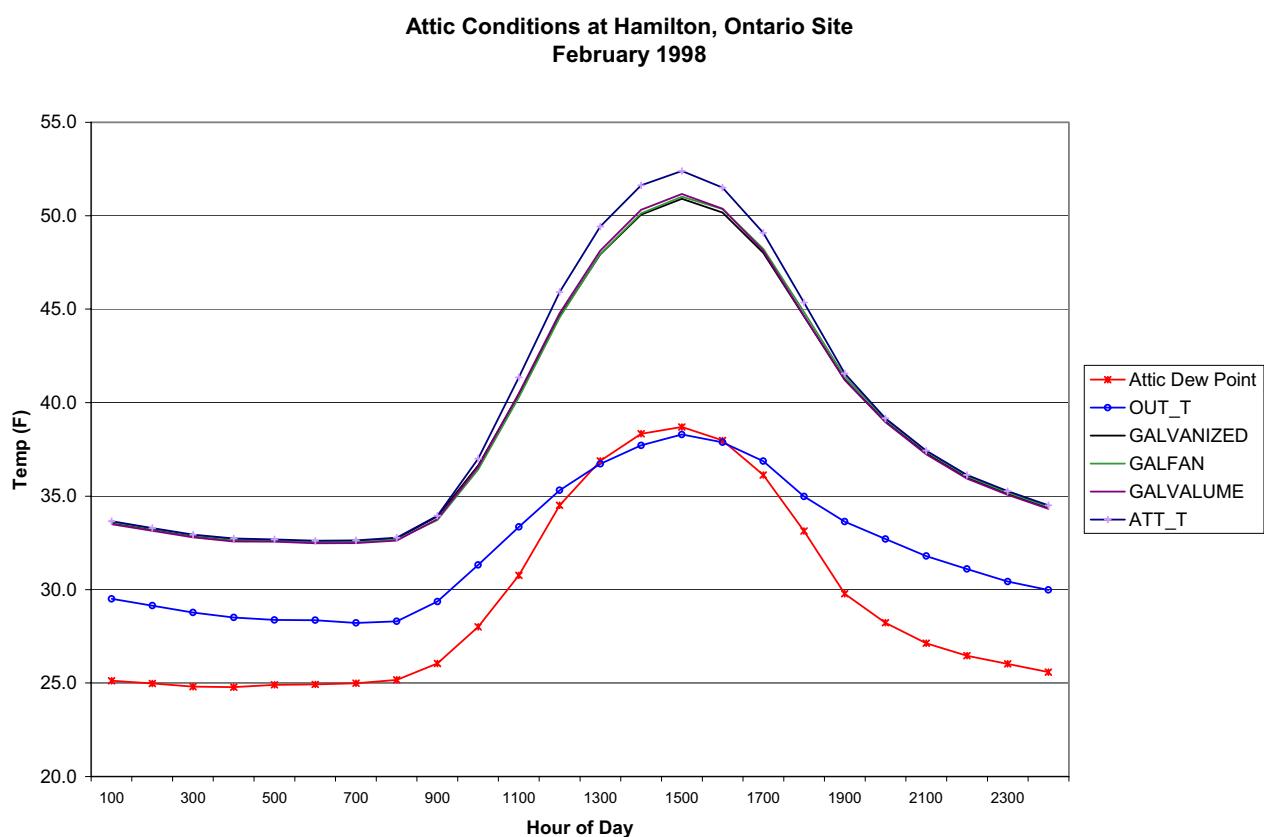
**Figure 15 - Temperatures vs. Dew Point at Hamilton Site**

A sample of the output from the dew point analysis is shown below in Figure 15. The graph depicts the temperatures of the test samples and framing components located in the ventilated attic space colony. It also compares these temperatures to the attic dew point temperature.

This analysis was performed for both the wall colony and the attic colony for every month of the year. In most instances, metal surface temperatures – as well as the surface temperatures of a wall stud and base plate – remained above dew point temperature for the space. This result demonstrates that the thermal performance and moisture control of the site were sufficient to prevent wetness in the wall cavity or the attic.

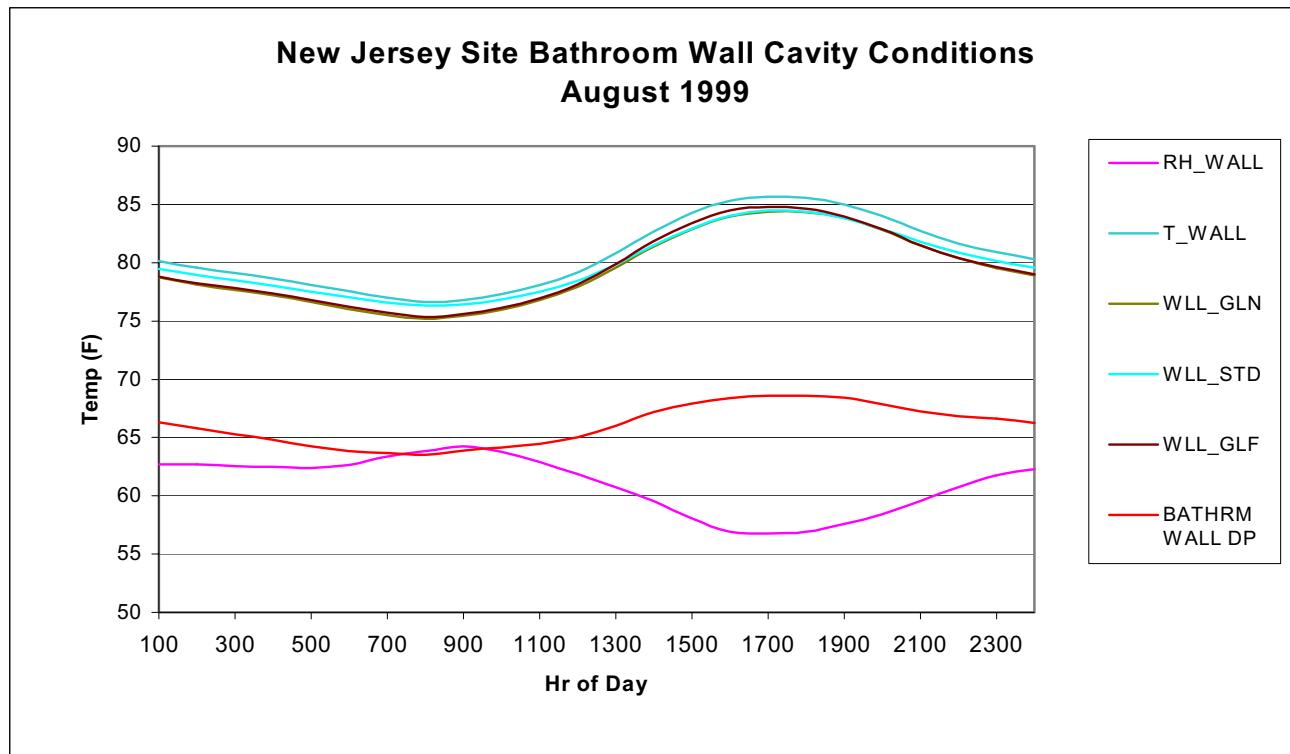
**Figure 16 - Temperatures vs. Dew Point at New Jersey Site**

The results of the one-year environmental analysis revealed that all measured building component (e.g., steel studs, joists) and sample temperatures remained above the dew point in all three colonies. This result was true for both the monthly analysis and for the hour-by-hour analysis of the entire year. None of the samples or building components (a tie down, deck joist, and floor joist) that were monitored for surface temperature experienced even 1 hour below dew point temperature. The first-floor joist area, exterior deck joist area, and bathroom exterior wall colonies all maintained temperature and humidity conditions that would prevent condensation from forming on the metal surfaces. An example from the New Jersey data analysis is shown in Figure 16.
